TECHNICAL REPORT REMR-CO-3

CASE HISTORIES OF CORPS BREAKWATER  
AND JETTY STRUCTURES

PACIFIC OCEAN DIVISION

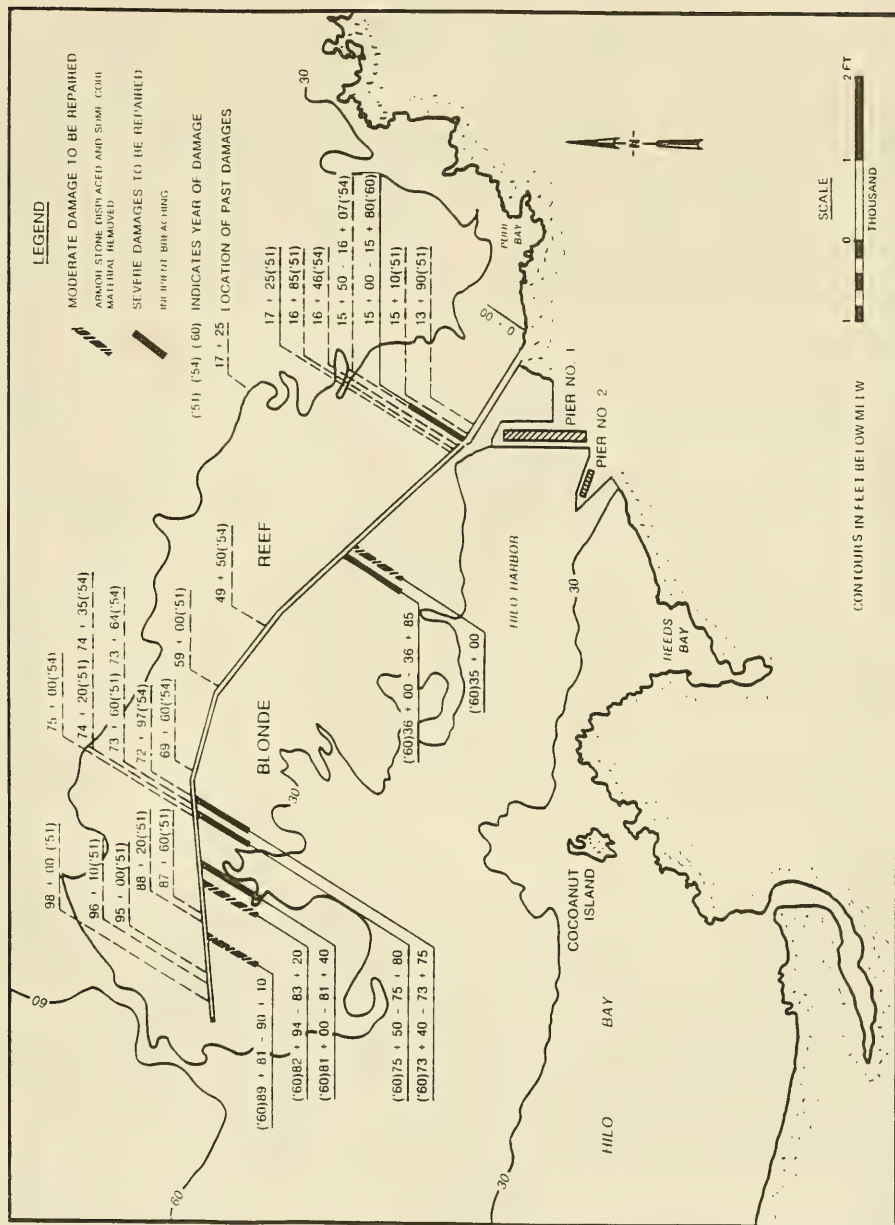
Figure 4. Hilo Breakwater damage summary, 1951-1960

1960	The tsunami of 1960 caused breakwater damage (Figure 4), but it was not as severe as that sustained by the 1946 tsunami. Less severe damage was attributed to the direction of wave attack. The 1960 approach was less direct than that of 1946; therefore, wave energy reaching the structure was less than what had occurred in 1946. Between 1946 and 1960 average annual maintenance costs were \$25,000. It was thought that the 1946-1948 repair work did not key the replacement armor into the existing structure, thus resulting in weaker cross sections in these repair areas.
1965	Storm waves of February 1965 caused additional damage at sta 15+00, 36+30, 73+40, 83+00, and 90+00.
1967	Between the 1960 and the 1967 tsunami, no repair work was done due to the possibility of total rebuilding of the breakwater as one leg of a proposed tsunami barrier for Hilo Harbor. The average annual cost of structure maintenance had been \$43,900 for the first 37 years of the project.

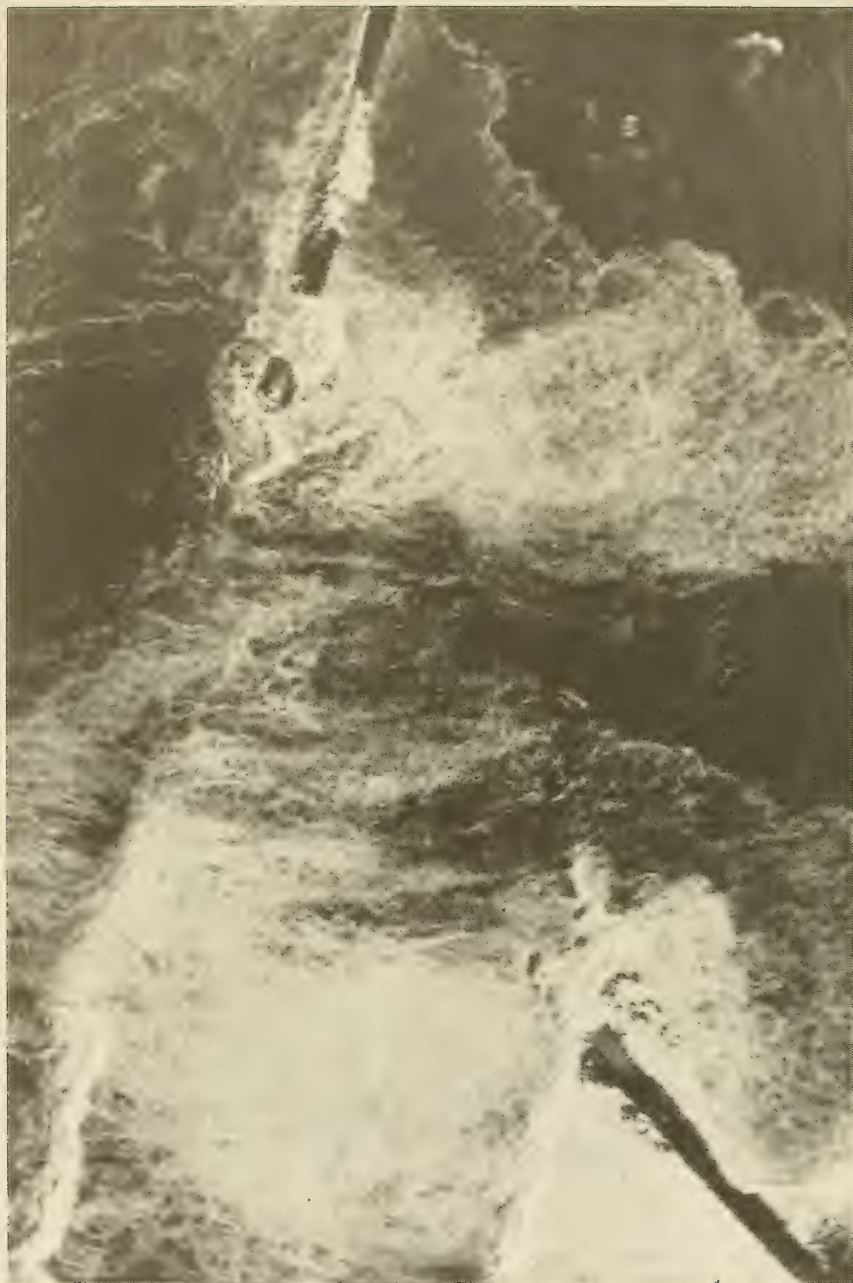
Figure 8. Kahului breakwater during storm of 22 November 1958

Date(s)	Construction and Rehabilitation History
1958	A storm (Figure 8) with estimated breaking wave heights at the structure of 25 ft caused severe damage to seaward ends of both breakwaters. The east breakwater was breached for a length of 154 ft in the original armor stone-tetrapod transition area, and at least six tetrapods were displaced from the head. On the west breakwater all the tetrapods (approximately 60 units) from the harbor-side quadrant of the head were swept away. The west breakwater's 1-V:2-H harbor-side slope appeared to be a major design deficiency.
1959	Stopgap repairs of damage from the November 1958 storm were completed, and design analysis for a major rehabilitation was initiated. These repairs consisted of construction of a heavy monolithic concrete cap (east breakwater, \$275,000) and placement of the heaviest available armor stone (12-ton minimum) on the seaward slope.

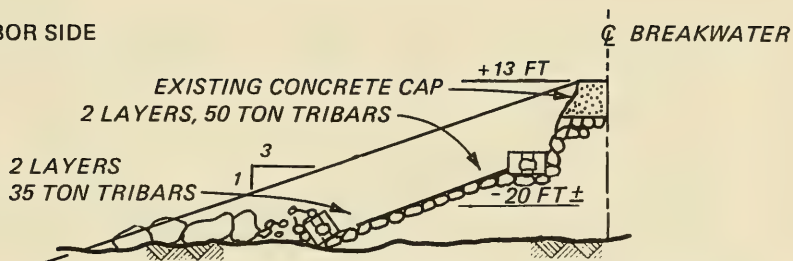
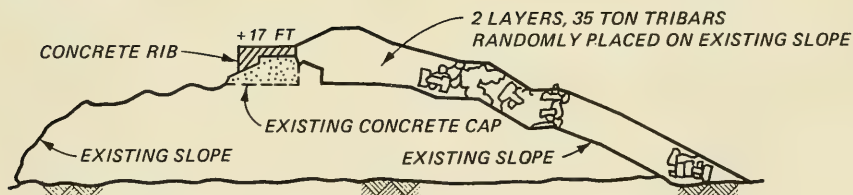
Figure 9. Kahului breakwater repair, 1966

1965	During 2-3 February, 1 month after awarding the tribar-placing contract, a storm with hindcasted deepwater wave heights of 27 ft and period of 17 sec caused damage to the heads of both breakwaters.
1966	Major rehabilitation (Figures 5 and 9(a,b)) consisted of repair of both breakwater heads and the first 355 ft shoreward of the east breakwater head. On the inboard quadrants of the breakwater heads, two layers of 35-ton tribars were placed over the lower third of the side slope, and two layers of 50-ton tribars were placed over the upper two-thirds. Two layers of 35-ton tribars were placed on the sea-side slope of the east breakwater head and buttressed against the concrete rib cap constructed on the crest; 827 and 181 35-ton reinforced tribars were placed on the east and west breakwaters, respectively; and 43 and 173 50-ton reinforced tribars were placed on the east and west breakwaters, respectively. Except for the concrete rib cap, all repair work was model tested (Jackson 1964). The total cost of repair work was \$1,560,000.

a. Tribar repairs to inboard quadrant of head sections

b. Repair of sea-side slope of east breakwater head

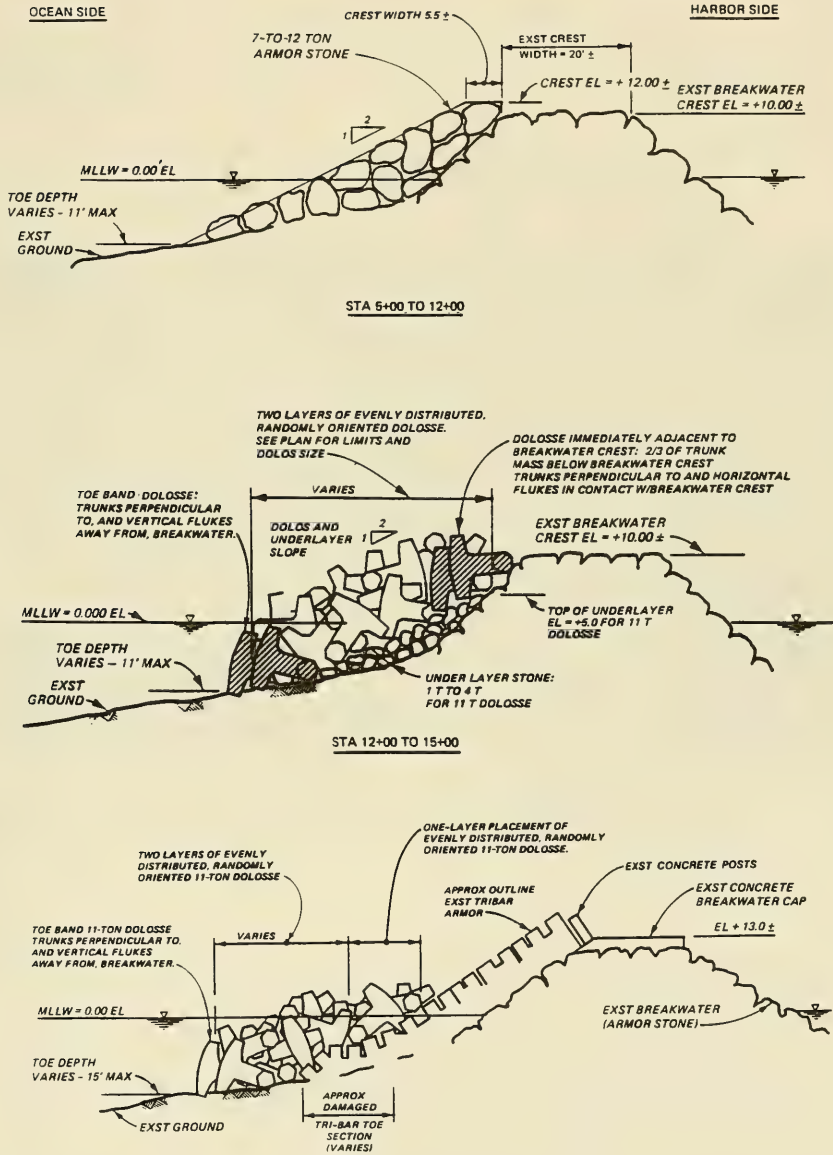
Figure 17. Typical cross sections for 1977 repair of Nawiliwili breakwater

1968- 1976	After the storm of 16 June 1976, a field inspection and subsequent underwater inspection revealed 98 tribars broken in the one-layer tribar area, 43 above water and 55 below water. Damage was thought to be due possibly to slippage of the tribar toe. Model tests of the tribar rehabilitation had recommended the use of large buttressing stone, and there is no evidence of their existence on the tribar toe.
1977	The existing one-layer tribars and a 300-ft section of the sea-side slope shoreward of this area were repaired (model tested by Davidson 1978). Two layers of 11-ton unreinforced dolosse (485 units) were placed from the toe to approximately +5.0 ft mllw over the one-layer tribar area. Two layers of the same size unit (449 units) were placed from the toe to the crown on the sea-side slope of the trunk for a distance 300 ft shoreward of the tribar area. The design condition for the dolosse overlaying the tribar was a 12-sec, 19.4-ft breaking wave in an 18.5-ft water depth. On the other hand, the design condition for the dolosse overlaying the old existing armor stone was a 16-sec, 8.9-ft breaking wave in a 10-ft water depth. Portions of the sea-side slope shoreward of this area (approximately 300 ft) were repaired with one layer of 7- to 12-ton stone. This armor stone repair was not model tested. The total cost of repairs was approximately \$2,000,000. Typical cross sections of the repair areas are shown in Figure 17.

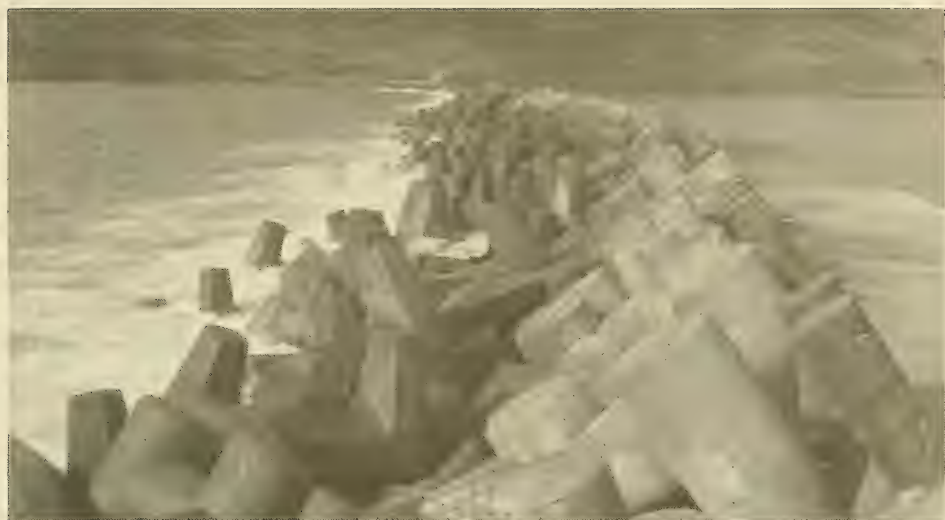
Figure 18. View from head of Nawiliwili breakwater, July 1984

Date(s)	Construction and Rehabilitation History
1979	A field inspection on 26 September 1979 revealed a total of seven dolosse and five tribars broken above the still-water level (swl) between sta 16+00 and 20+00. No repair work was recommended.
1982	A reconnaissance report of August 27 expressed concern of the steep and degraded harbor-side slopes, and plans were initiated for rehabilitation work. Hurricane Iwa of November 23 reportedly produced depth-limited breaking waves at the structure. An inspection subsequent to the hurricane revealed considerable movement of concrete armor units which may have caused armor unit breakage below water. Nine dolosse and one tribar unit were found broken. Movement and shifting of stones on the crest of the breakwater were noted in three areas. Also, overtopping waves had displaced harbor-side stone and in one area had created a trough along the harbor-side toe.

1983	An underwater inspection was conducted on 9 August. This detailed inspection revealed that the underwater slope of the breakwater head was approximately 1V:1H, much steeper than it was thought to be. The inspectors recommended repair of the head to prevent a possible catastrophic failure of the head that could be initiated on steep underwater slopes.
1984	Figure 18 is a photograph of the breakwater taken from the head looking landward. A general design memorandum for the rehabilitation of the breakwater in 1985 was prepared. The proposed work was as follows: one and two layers of randomly placed dolosse on the sea- and harbor-side slopes of the head; one layer of 11-ton dolosse on the sea-side slope between stations 18+35 and 20+45; one layer of uniformly placed, 6.5-ton tribars on the harbor-side slope between sta 12+00 and 15+00; and concrete ribs on the crown between sta 12+00 and 20+45. Portions of this proposed work were model tested (Markle and Herrington 1983). The estimated first cost of this rehabilitation was \$3,500,000 based on January 1984 price levels.

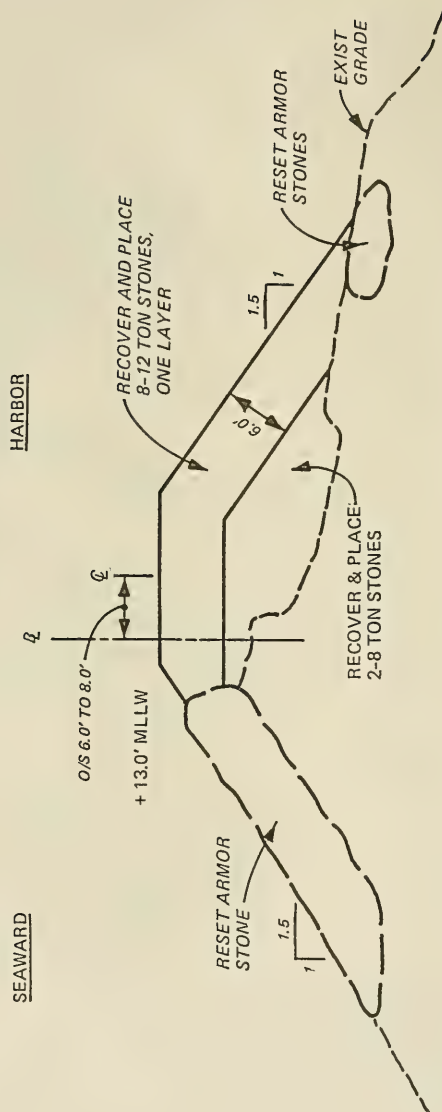
Figure 22. Typical cross section showing 1984 repair of Port Allen breakwater head

<u>Date(s)</u>	<u>Construction and Rehabilitation History</u>
1935	The 1,200-ft-long structure was completed as an extension to a privately constructed breakwater (Figure 21).
1982	Until damaged by Hurricane Iwa of November 23, the old 8-ton keyed-and-fitted armor stone structure had no repair history. The breakwater light at the seaward end had been damaged and repaired several times (Coast Guard cost) prior to its present destruction. The estimated 20-ft breaking waves at the structure first dislodged the stones on the inboard crest which eventually resulted in the total destruction of the outer 130 ft of the breakwater. Overtopping waves also displaced crest stone and exposed under-layer stone on a 150-ft length at the extreme root of the structure. Minor damage also was sustained along the inboard slope.
1984	The head was rebuilt, and the minor damage on the inboard slope was repaired at a cost of \$178,000. The breakwater was shortened to a total length of 1,126 ft. The outer 74 ft was abandoned. The repair was accomplished by resetting stone remaining on the structure and by retrieving stone from the harbor and replacing it on the structure using the old keyed-and-fitted construction (Figure 22). The crown elevation on the last 80 ft of structure was increased to +13.0-ft mllw. This was done to improve the stability of the inboard slope by decreasing wave overtopping. The root of the breakwater was not repaired.
